**ENVIRONMENTAL PROTECTION AGENCY
TECHNICAL ENFORCEMENT SUPPORT
AT
HAZARDOUS WASTE SITES**

**FINAL
RCRA FACILITY ASSESSMENT REPORT**

**MONSANTO-QUEENY PLANT
1700 SOUTH SECOND STREET
ST. LOUIS, MISSOURI
EPA ID. NO. MOD004954111**

**PREPARED BY
JACOBS ENGINEERING GROUP INC.
LENEXA, KANSAS
PROJECT NO. 05-B667-00**

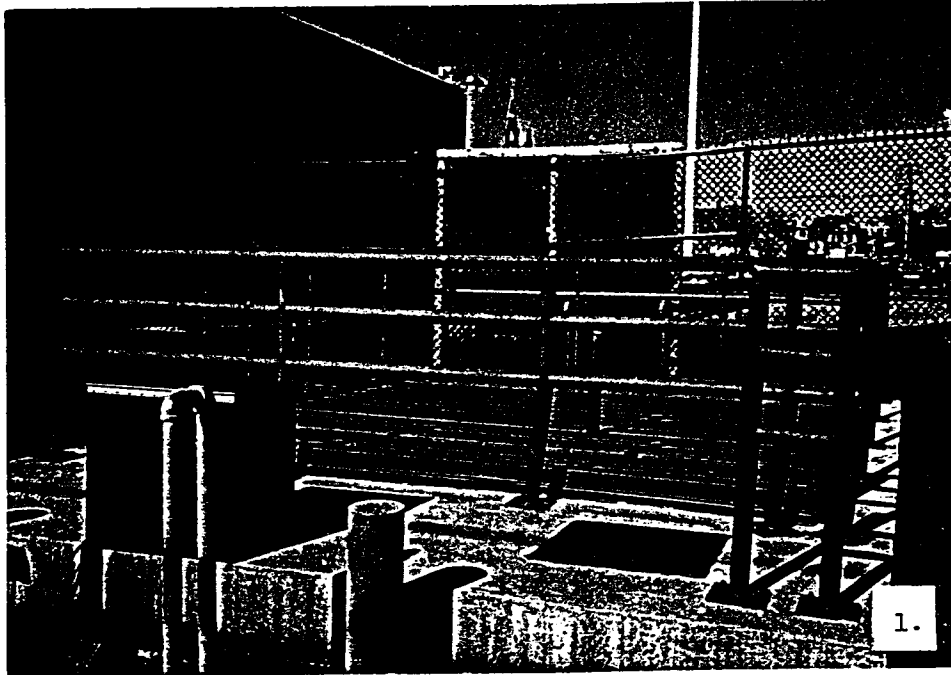
PHOTOGRAPH NO. 1
OFFICIAL PHOTOGRAPH
JACOBS ENGINEERING GROUP

Subject: Laboratory Coalescer

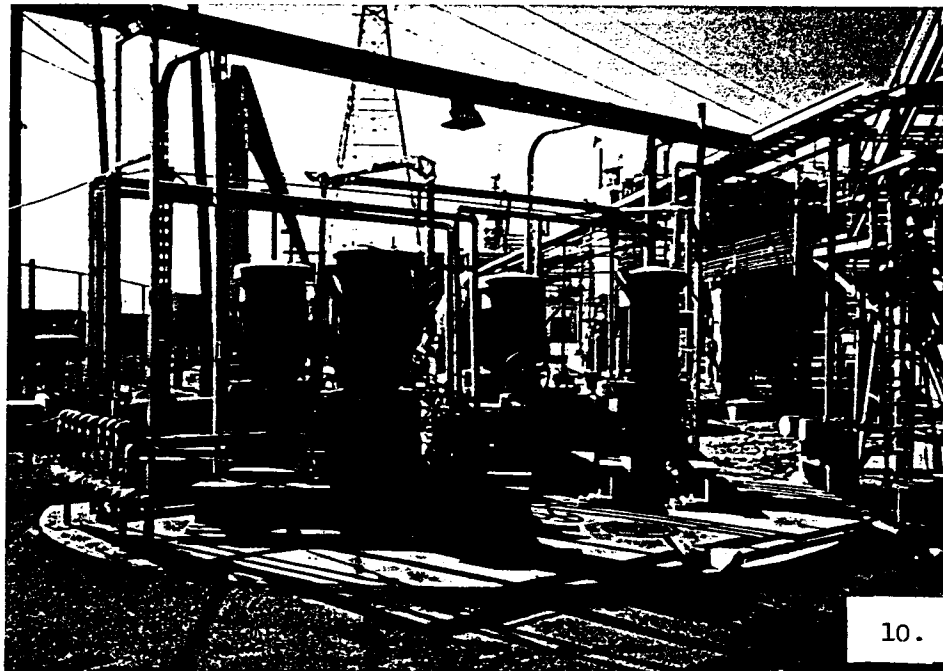
PHOTOGRAPH NO. 10
OFFICIAL PHOTOGRAPH
JACOBS ENGINEERING GROUP

Subject: Pump Pit
Location: Monsanto-Queeny Plant, St. Louis, Missouri
Date: March 1, 1988 Time: 1050
Photographer: Carla Rellergert File No: 05-B667-00
Film: Kodak 200 ASA Witness: John Smith
Direction of Photograph: South

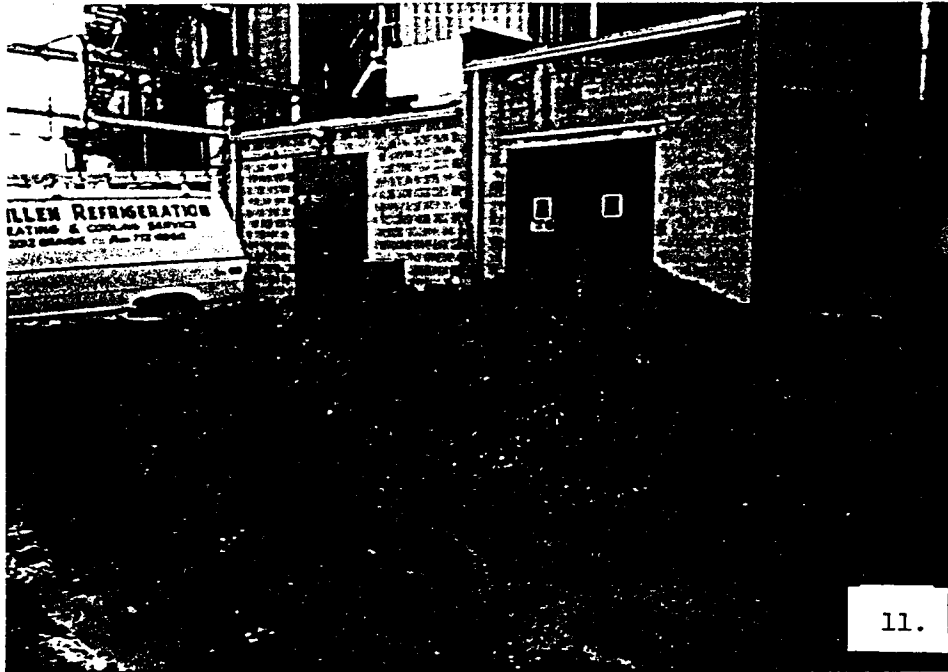
PHOTOGRAPH NO. 11
OFFICIAL PHOTOGRAPH
JACOBS ENGINEERING GROUP

Subject: Boiler Slag Pile

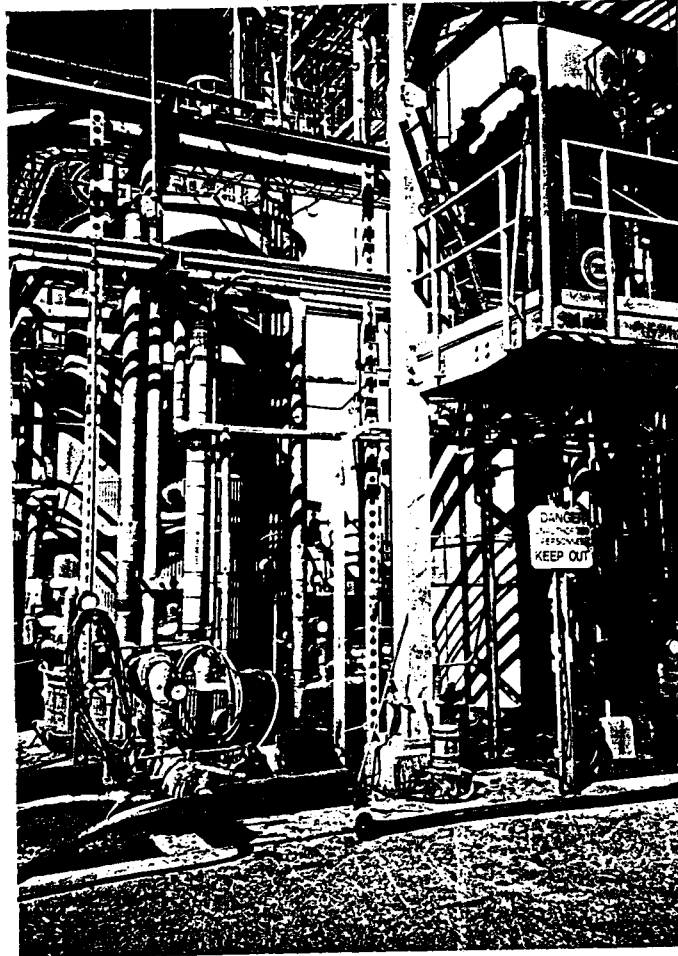
PHOTOGRAPH NO. 17
OFFICIAL PHOTOGRAPH
JACOBS ENGINEERING GROUP

Subject: CAC Incinerator Waste Storage Tanks
Location: Monsanto-Queeny Plant, St. Louis, Missouri
Date: March 1, 1988 Time: 1115
Photographer: Carla Rellergert File No: 05-B667-00
Film: ASA 200 Kodak Witness: John Smith
Direction of Photograph: Northwest

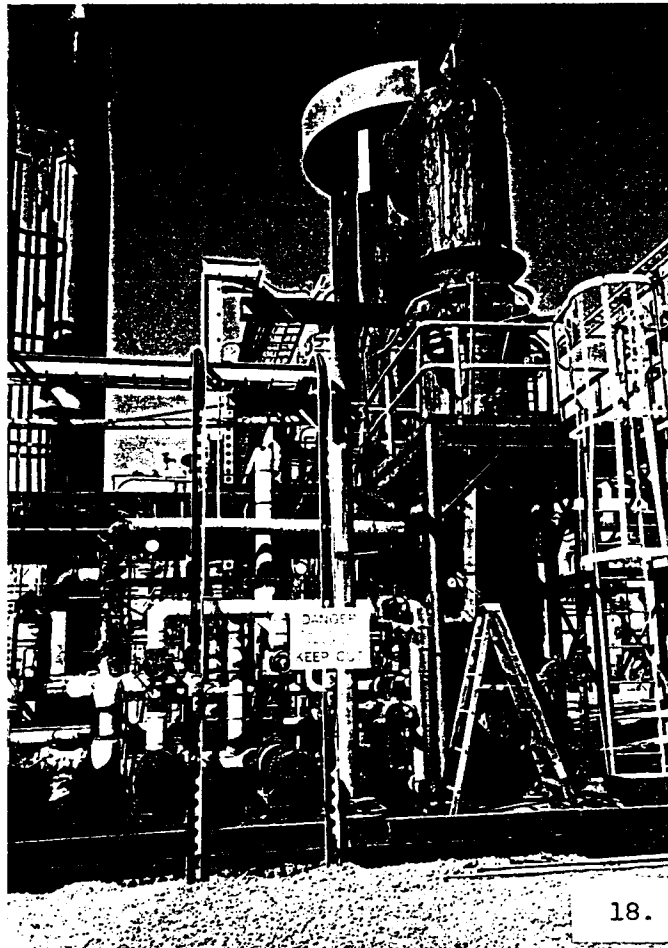
PHOTOGRAPH NO. 18
OFFICIAL PHOTOGRAPH
JACOBS ENGINEERING GROUP

Subject: CAC Incinerator
Location: Monsanto-Queeny Plant, St. Louis, Missouri
Date: March 1, 1988 Time: 1120
Photographer: Carla Rellergert File No: 05-B667-00
Film: Kodak 200 ASA Witness: John Smith
Direction of Photograph: West

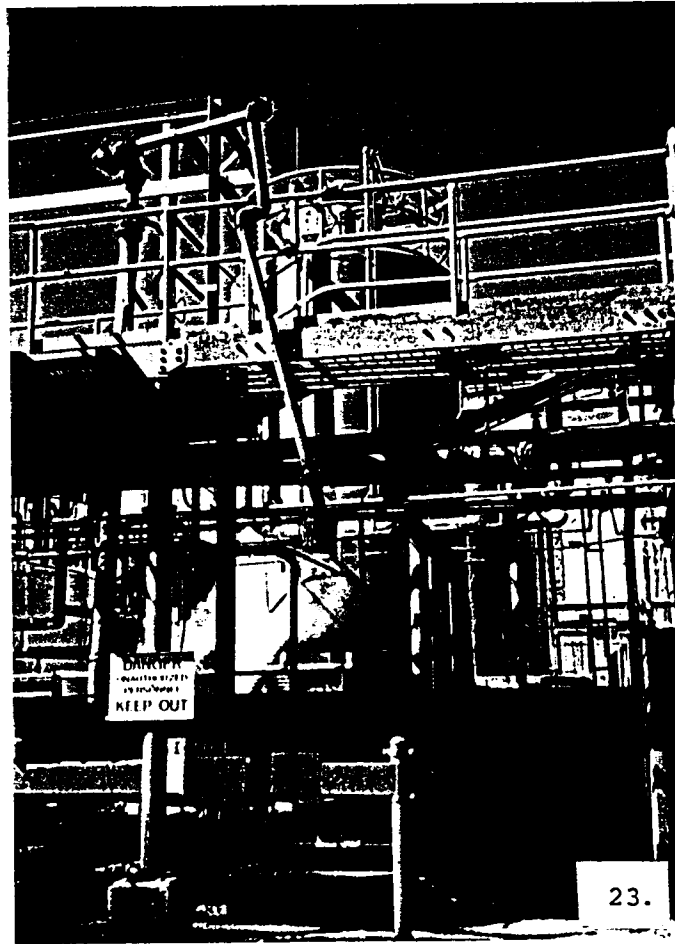
PHOTOGRAPH NO. 23
OFFICIAL PHOTOGRAPH
JACOBS ENGINEERING GROUP

Subject: Azomethine Residue Holding Tank

As noted above, this unit handles the same wastes as does the azomethine residue storage tank. This waste contains formaldehyde, an Appendix VIII waste, and kerosene, which likely contains Appendix VIII constituents.
